## CASE HISTORY

**Owner:** Harris County W.C. ID. No.21

**Location:** I-10 East & Sheldon Road

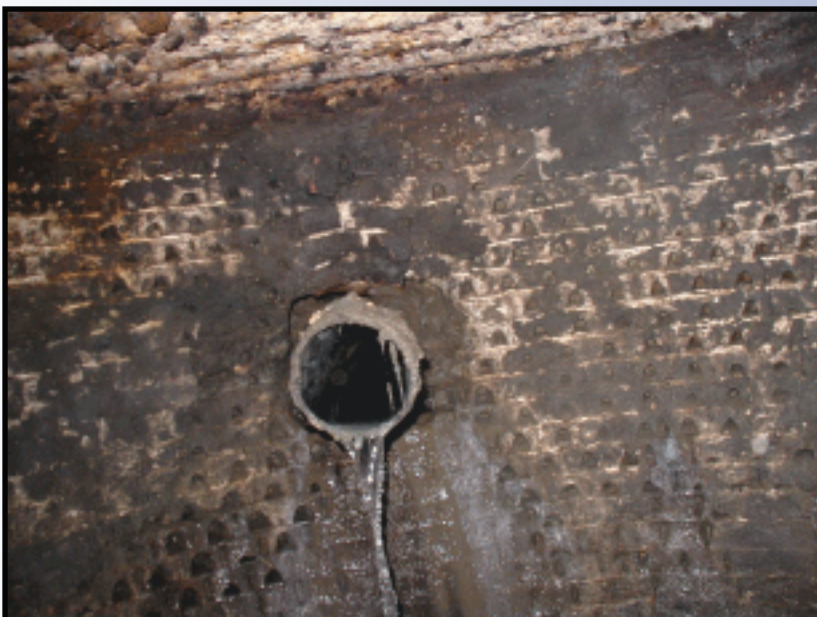
BEFORE

**Details:** Eight (8') diameter, ten (10') foot deep clay brick wet well. The wet well is exhibiting severe H<sub>2</sub>S attack creating structural fatigue and major inflow/ infiltration problems. The structure was constructed in the mid 1940's. Due to the holes in the bricks and heavy terrintail rain the district was experiencing sewerage overflows and fines from TECQ.
