CASE HISTORY

Owner: Harris County Woodedge Suvdivision

Location: Woodedge Drive Houston, TX

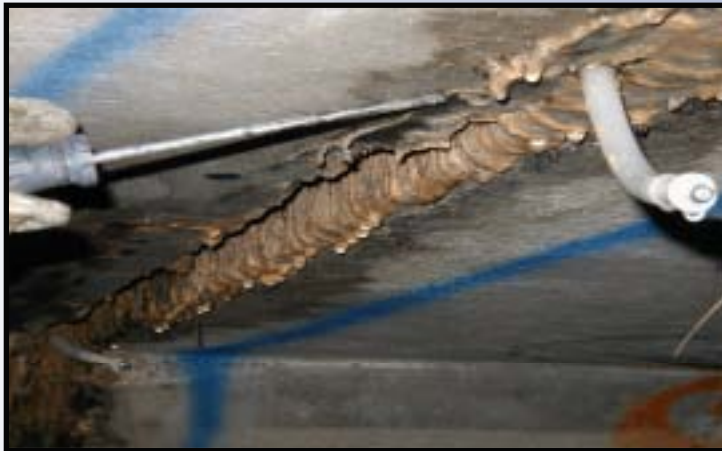
Details: Harris County Flood Control was experiencing heavy inflow and infiltration from failing joints in their neighborhood storm sewer system. These concrete box culverts were misaligned and the original mastic was missing and creacking this problem. Large sink holes were developing above ground and were creating houses and businesses major concern of foundation collapse.

EXPOSED JOINT

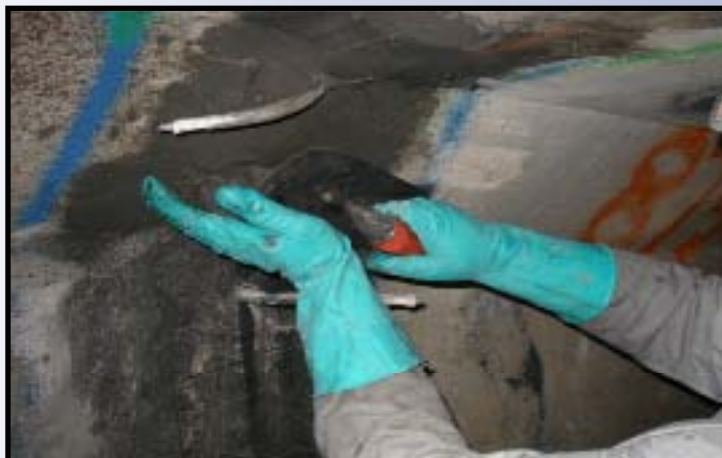
SEALING JOINT

Rehabilitation Method: Seal joint with Reliner MSP structural cement liner and inject with hydrophilic chemical grout creating a 360° waterproof grout collar.

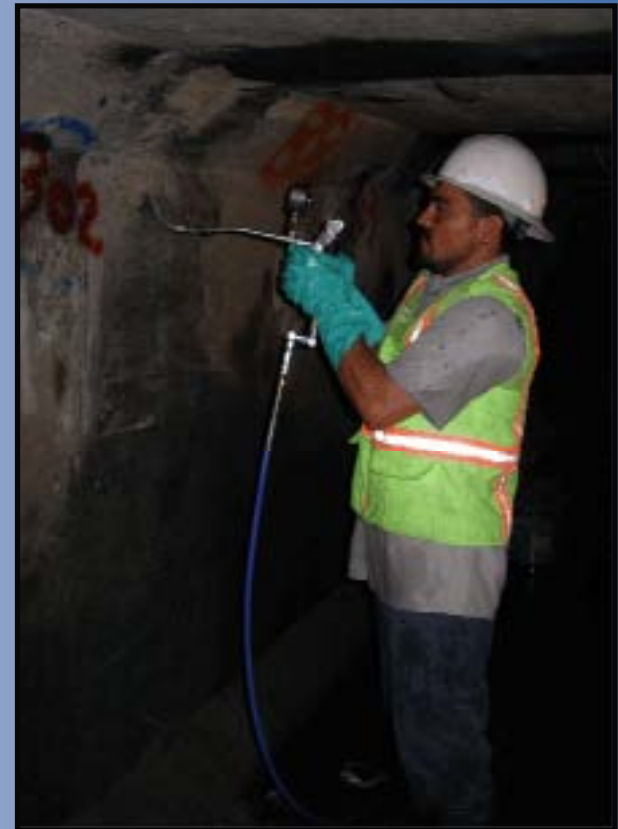
INJECTION

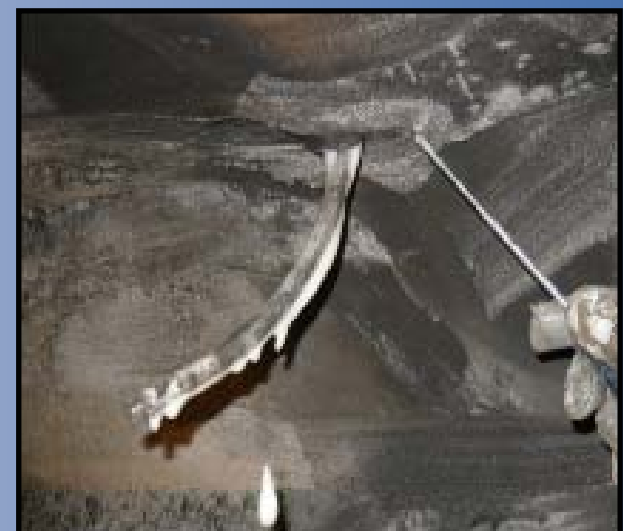
HYDROPHILLIC GROUT AT WORK
