CASE HISTORY

“Houston, We Have A Problem” Manhole Rehabilitation Method Saves Taxpayer Money

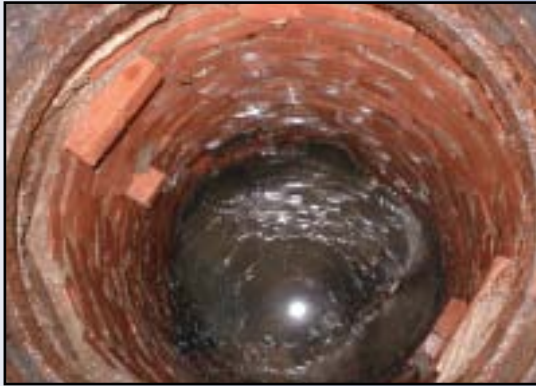
*Brick manhole cleaned and ready for
Cement Liner*

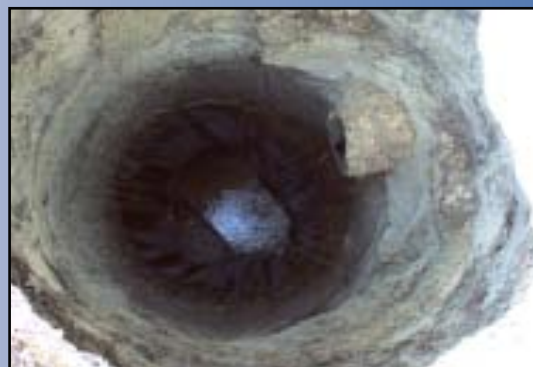
This region experiences very hot and humid climate most of the year except for a few weeks in the winter. This type of atmosphere can create an extremely harsh and aggressive environment especially in sanitary sewer manholes. This situation has created manhole failures in dramatic numbers and had forced the city to start taking means of replacing their manholes. Placed close to the ocean and being that the water table is relatively high the city has been trying to combat this problem but, realized that the remove and replace method was too slow, very expensive and would not be able to keep up with the pace of the failing manholes in their area.

*Precast manhole experiencing high
deterioration and corrosion with exposed
reinforced and structural fatigue*

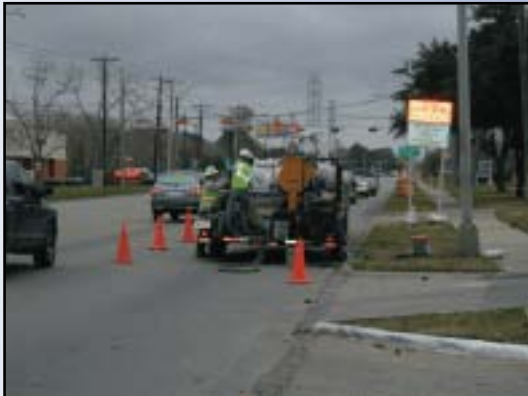
Manhole crew mixing material for application of Reliner MSP cement liner.

Over the next several months SCM, Inc. would rehabilitate and restore the 100 manholes in this project with great ease and success. SCM, Inc. uses specialized equipment which includes but is not limited to a custom trailer, high pressure washer (min 3500 psi), high capacity water tank with a city approved water gap system, mounted mortar mixer and a rotor-stator pump specifically designed to apply sprayable cements and mortars.

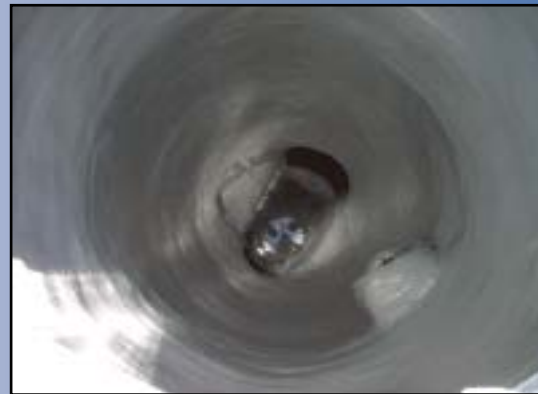
Manhole has been rehabilitated using RelinerMSP cement and StandardShield epoxy coating.

After all manholes had been lined with Standard Cement Materials' **StandardShield** cement, vacuum testing was performed to ensure that the manholes were air tight and no leaks were present, confirming that inflow and infiltration problems would be ceased for many years to come.

In addition to the microsilica cement liner, SCM, Inc. also used their 100% solids, spray applied **StandardShield** epoxy coating to add further protection to manholes that were experiencing high concentrations of Hydrogen Sulfate attack. These manholes were identified individually from the group receiving microsilica cement only and were dealt with on a case-by-case basis.
